Heating System Problems

Lack of knowledge can be the cause

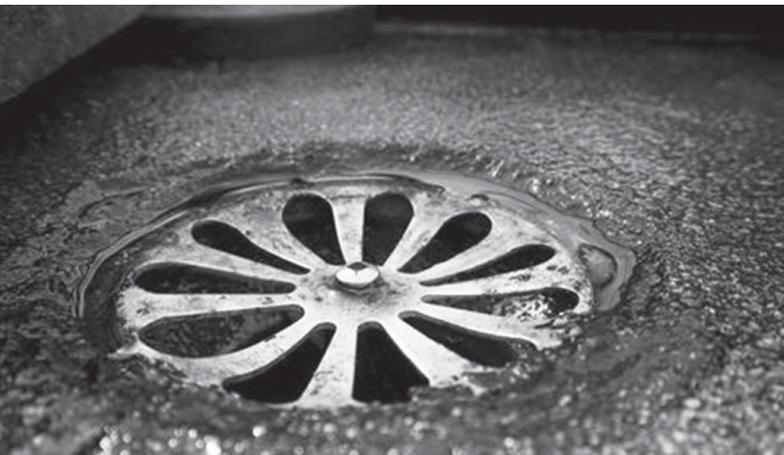
A drainage system that led to a floor drain in another room, built by a janitor to deal with a leaky boiler, was only a temporary fix. A much bigger problem loomed.

The final piece was the piping of the relief valve. Connected to the bottom of the discharge line from the valve was a piece of 6" flue pipe, which was positioned using a milk crate that was carefully wedged against the boiler. From there, more flue pipe was attached. The building's janitor had built a drainage system using the flue pipe that ran from the bottom of the relief valve piping in the boiler room to a back room where a floor drain was located. The relief valve would constantly dump water onto the floor every time the boiler fired, and since he was *tired* of mopping up the water, the janitor built the "drainage system" that emptied into a floor drain. However, when the boiler turned off, the pressure in the system would drop. This caused the PRV to feed gallons of make-up water back into the system.

The cause of this whole miserable story was the hidden, waterlogged steel expansion tank that was hiding above the sheetrock. The tank had been installed incorrectly when the boiler was replaced. Initially, the janitor had access to the tank and he would just drain it down every time it became waterlogged. However, once the new ceiling went up, it covered the tank and the problems multiplied. Instead of solving the real issue of why the tank was waterlogging in the first place, the janitor just did what he could, which was build a "drainage system."

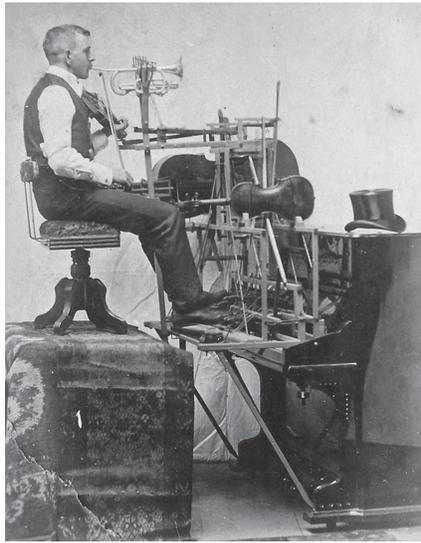
Like a one-man band, the connections of a one-pipe steam heating system need to be positioned correctly for everything to work harmoniously.

This seemed innocent enough. Unfortunately, there exists another rule governing the size, the pitch and the length of pipe run used to feed each radiator. This is critical, especially in a one-pipe system, and the reason is basic. The pipe that is used to deliver steam out to the radiator is also asked to bring the condensate formed in the radiator back to the main. This occurs simultaneously, so it is important that the velocity of the steam (how fast it is traveling towards the radiator) doesn't exceed a maximum. If it

does, the condensate won't drain back and in fact will be driven towards the radiator, causing banging and sloshing noises.

Think of it this way—steam traveling in a pipe is like wind heading in one direction, while the condensate is using gravity to drain back underneath this wind in the opposite direction. So long as the tunnel is big enough, and there is sufficient pitch, things will work as they should.
